Intel[®] Mobile Celeron[™] Processor at 466 MHz, 433 MHz, 400 MHz, 366 MHz, 333 MHz, 300 MHz, and 266 MHz Specification Update

Release Date: February 2001

Order Number: 244444-022

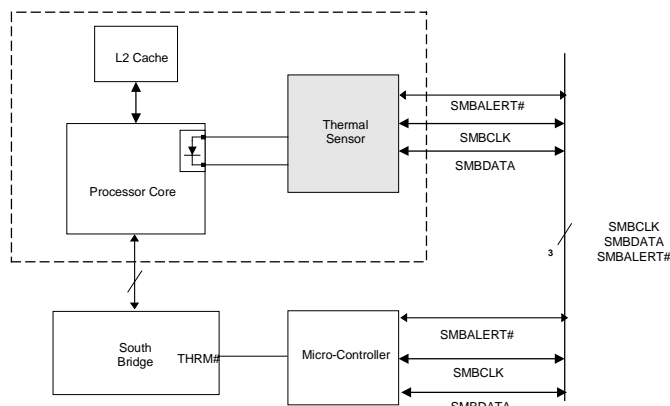
Figure 1. An Example of Microcontroller Driven Thermal Management

Problem: The Intel Celeron Processor Mobile Module has a thermal sensor that monitors the processor core's temperature. Please note that desktop systems could have a similar thermal device. The thermal sensor asserts SMBALERT# if the processor temperature exceeds the temperature limits set in the Alarm Threshold Registers (T_{HIGH} , T_{LOW}). It also sets the corresponding Status Register bits to identify the cause of the interrupt. Figure 1 gives one example of the how the SMBALERT# signal could be used in a system.

Implication: There is no system impact from this erratum if temperature polling is used for processor thermal management. If the SMBALERT# interrupt is employed to manage processor thermal sensing, then servicing the false interrupt may result in premature system action depending on the software and hardware implementations used. The rate of the false interrupts is less than the auto-convert rate of the thermal sensor.
